HNF-27217-FP
Revision 1

Managing The Retrieval Risk of Buried Transuranic (TRU) Waste With Unique Characteristics

To Be Presented at
WM06

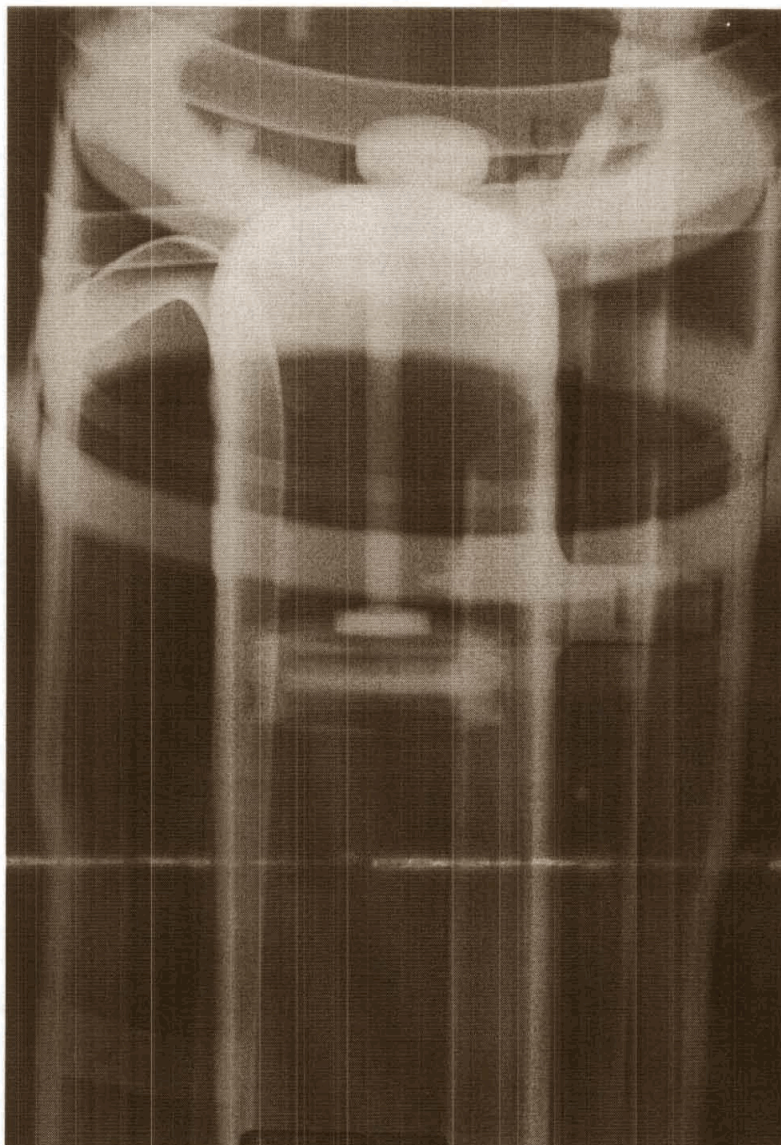
Of interest were the configuration of the internal packaging, the presence of the vent plug, and the structural integrity of the bird cage. An initial radiograph was taken to determine the orientation of the vent plug on the source capsule of each Pu-238 drum. The radiographic equipment was then repositioned to obtain a profile of the vent plug. Radiographic film was placed directly behind the drum and duplicate radiographs were shot to provide both Hanford and SRS with a record of the inspection of each drum. Radiographs of the first three drums indicated that the drum containment was as expected. The structural integrity of the birdcage was important since the documented safety analysis took credit for the spacing provided by the birdcage. The birdcage radiographs indicated no change in geometry compared to the drawings. Figures 3 and 4 are radiograph photographs illustrating characteristics of the source capsule and internal aluminum cans. Detailed examination of the radiographs clearly showed the individual aluminum can walls, the aluminum can Magneform® sealed tops, the conical vent plug, and the shape of the plutonium oxide in the bottom of the can. In some cans, objects were observed that may have been used to load the oxide into the cans.

Figure 3. Radiograph photograph of the top of a source capsule, vent plug, and nested aluminum cans.

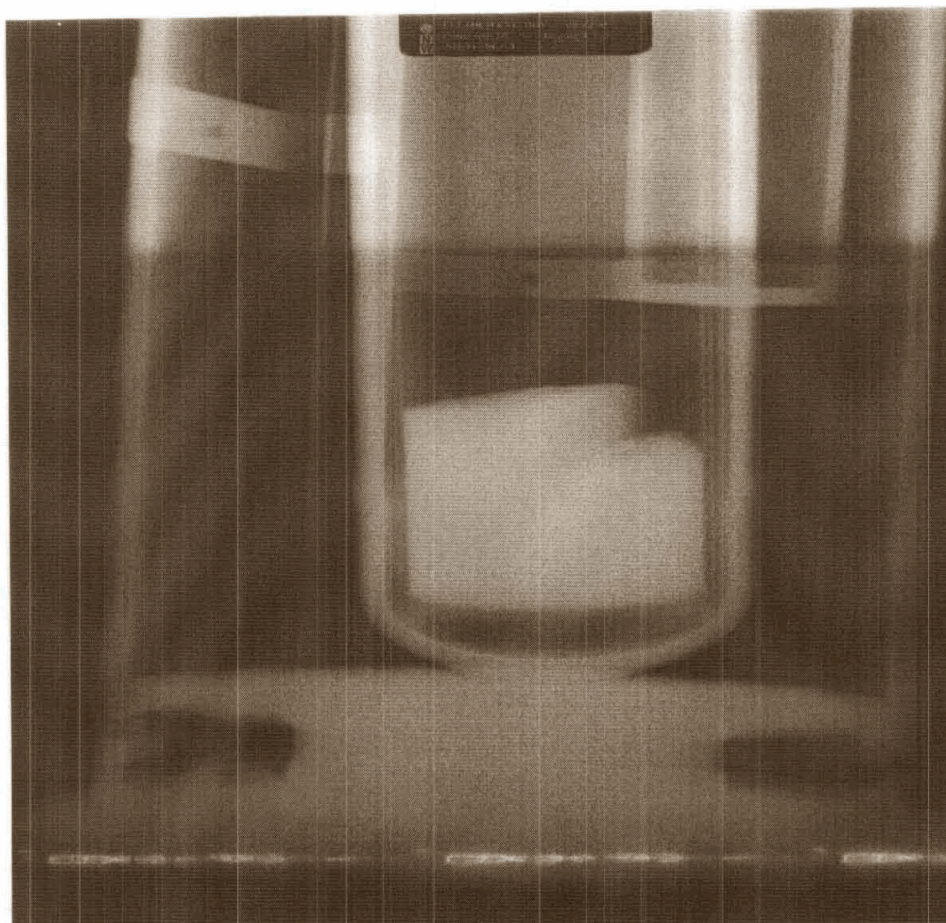
Figure 4. Radiograph photograph of the bottom of a source capsule, the plutonium oxide, and a shipping container.
